# Manhole Inspection Summary

Manhole # S15C\_\_036MH

**Location** Address: **2700 LAURETTA-FRANKLIN** Cross Street: **ASHBURTON ST**

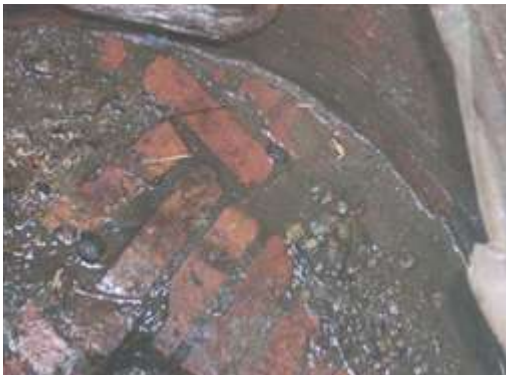
Defect 3

**Steps** Count: **2** Missing: **0** ☒ **Corroded**

CORRODED BOTTOM STEP

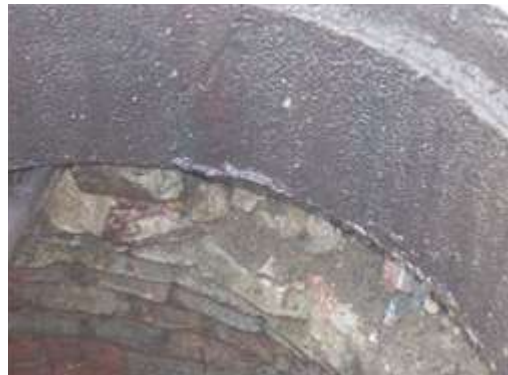
Defect 2

**Chimney / Frame Adjustment** ☒ Exists Material: **Brick** ☐ Parged Height: **3** (in.)  
Condition: ☐ Sound ☐ Cracked ☐ Root Intrusion ☐ Loose Brick ☒ **Deteriorated**  
Infiltration: ☒ None ☐ Joint ☐ Cracks ☐ Mortar ☐ Roots ☐ Wall

CHIMNEY DETERIORATION

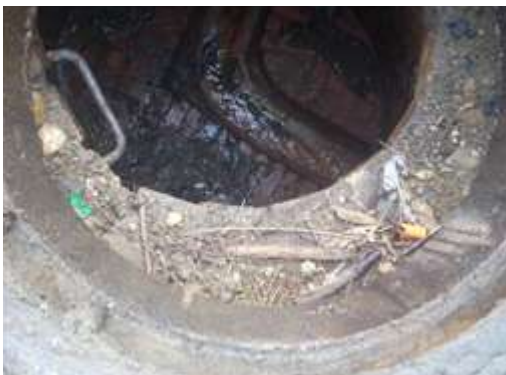
Defect 1

**Frame** Offset: **8** (in.) Condition: ☒ Sound ☐ Cracked ☐ Leaks

MAJOR FRAM OFFSET

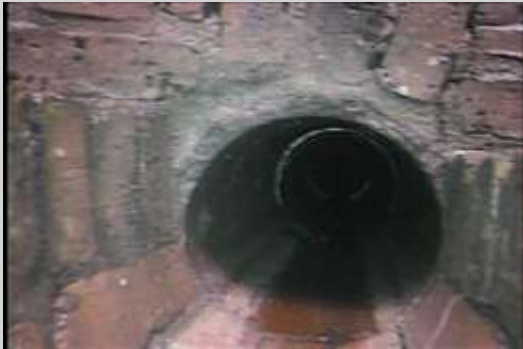
12 O'Clock Outflow

8 in. Circular Gravity Sewer  
Pipe Out @ 12 O'Clock

Pipe Height: **8.4** (in.) Rod and Bar (Angled)  
Pipe Material: **Clay** ☐ Pipe Lined  
Invert Depth: **5.64** (ft.) Flow Characteristics: **Slow**  
Deposits: ☒ None ☐ Mud ☐ Sludge ☐ Debris ☐ Grease  
Silt Depth: (in.) Deposits Extent:  
Infiltration: **None** Pipe Seal Cond: **Sound**

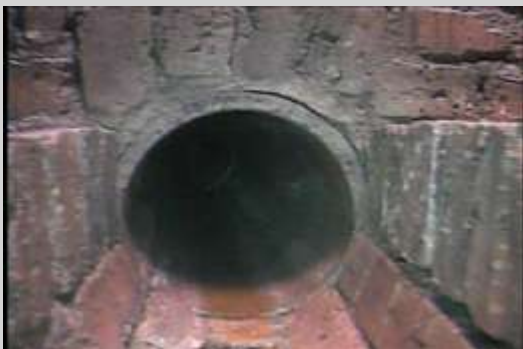
3 O'Clock Inflow

8 in. Circular Gravity Sewer  
Pipe In @ 3 O'Clock

Pipe Height: **8.4** (in.) Rod and Bar (Angled)  
Pipe Material: **Clay** ☐ Pipe Lined  
Invert Depth: **5.58** (ft.) Flow Characteristics: **Slow**  
Deposits: ☒ None ☐ Mud ☐ Sludge ☐ Debris ☐ Grease  
Silt Depth: (in.) Deposits Extent:  
Infiltration: **None** Pipe Seal Cond: **Sound**
